Effects of mechanical loading on the degradability and mechanical properties of the nanocalcium-deficient hydroxyapatite–multi(amino acid) copolymer composite membrane tube for guided bone regeneration

Hong Duan¹
 Hongsheng Yang¹
 Yan Xiong¹
 Bin Zhang¹
 Cheng Ren¹
 Li Min¹
 Wenli Zhang¹
 Yonggang Yan²
 Hong Li²
 Fuxing Pei¹
 Chongqi Tu¹

¹Department of Orthopedics, ²School of Physical Science and Technology, Sichuan University, Chengdu, People's Republic of China

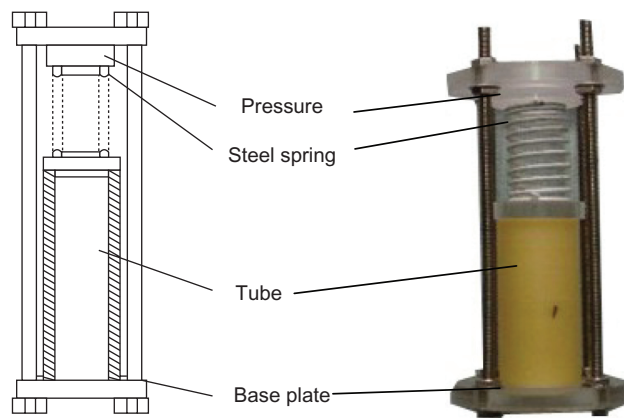
Figure 1 Schematic of self-designed loading device (left) and photo of device (right). The membrane tubes' mechanical strength changed: after degradation of 3 months, six membrane tubes of each group were dried naturally in air, and then axial compression and three-point bending-stress tests were performed. The stress-strain curve was recorded. The pressure signal was recorded and analyzed by a computer data-acquisition system.

was gradually increased according to the value on the display until 40 ± 0.5 N or 50 ± 0.5 N. To maintain the stability of the loading force, the nut on the metal rod was screwed tightly and fixed by denture powder, and then the compressed spring could provide continuous mechanical loading on the membrane tubes. The experimental group samples were divided into two groups by different loading (40 N/ 50 N). Each group had 15 samples that were fastened on the loading device and placed in a glass vessel containing phosphate-buffered saline (PBS; pH = 7.4 ± 0.2). Fifteen nonloaded samples (control group) were placed in the same glass vessel containing PBS as the experimental group. The degradation of membrane tubes was carried out in a shaking water bath (37.0°C and 30 rpm). The PBS was replenished every 2 weeks. The pH of the PBS was measured before being refreshed every 2 weeks using an electrolyte-type pH meter (PS-25; Leici Instrument Factory, Shanghai, People's Republic of China). The color of the solution, and the presence or absence of other substance precipitation changes were observed in the degradation period. Scanning electron microscopy (SEM) was used to observe membrane tubes' surface-morphology changes in each group every month randomly. Two experimental groups and the control group were detected in the internal cross-section changes by SEM and infrared analysis before degradation, after 1, 2, and 3 months' degradation. Six samples of three groups (two samples from each group) were washed and dried every month before the residual weight (W_t) was calculated. The weight-loss ratio was calculated according to the following equation:

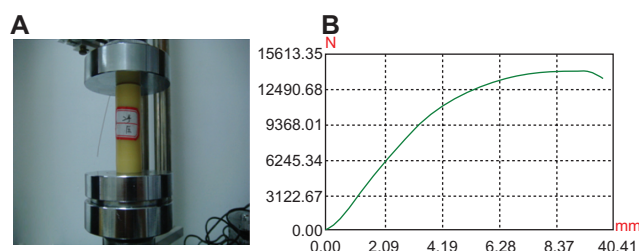
Figure 2 (A) Axial compression test of the straight tube; (B) stress-strain curve.

The elastic modulus of n-CDHA-MAC straight membrane tubes was 3.5 ± 1.8 GPa, while goats' femur was 3.66 ± 0.7 GPa. The compressive and bending strengths of straight membrane tubes were 66.4 ± 10.2 MPa and 840.7 ± 12.1 MPa, which were lower than the strength of goat femoral bone (69.0 ± 5.5 MPa and 900.2 ± 17.3 MPa), while the differences were not statistically significant between the two groups ($P > 0.05$). Therefore, the straight membrane tube had comparable mechanical strength with goat femur (Table 2). Further, in mechanical experimentation, the n-CDHA-MAC tube underwent deformation with local cracks but no occurrence of chipping, indicating that the membrane tube had high viscoelastic characteristics. Mechanical test curves of the two groups are shown in Figures 2B, 3B, 4B, and 5B.

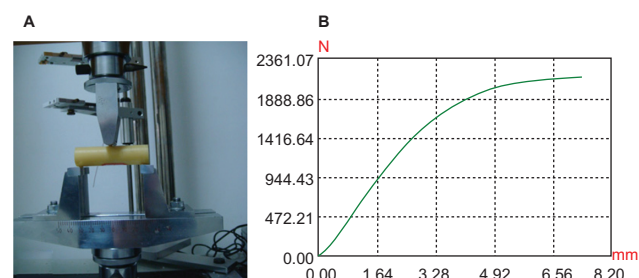
Figure 3 (A) Three-point bending test of the straight membrane tube; (B) stress-strain curve.

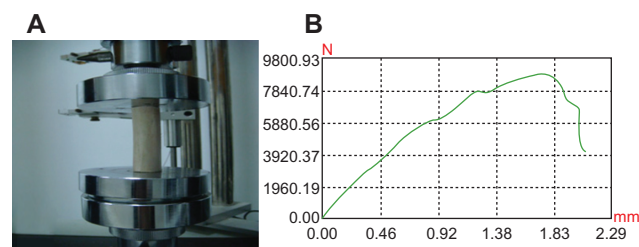
Figure 4 (A) Axial compression test of goat mid-femur; (B) stress-strain curve.

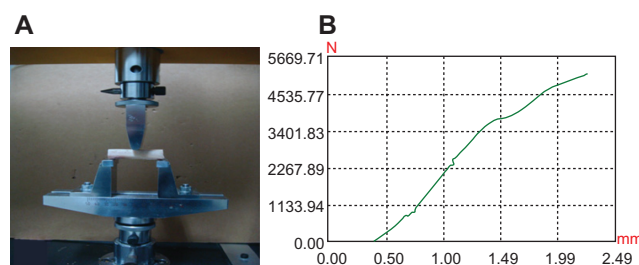
Figure 5 (A) Three-point bending test of the goat mid-femur; (B) stress-strain curve.

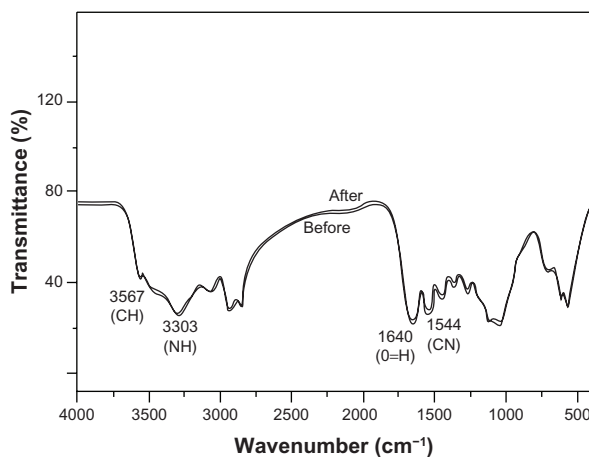
Figure 9 Fourier-transform infrared spectra of membrane tube before and after soaking. The membrane tubes in the phosphate-buffered saline degradation were removed to calculate the weight loss (%) after 1, 2, and 3 months. During the 3-month degradation, the weights of the membrane tubes had decreased, while the two loaded groups decreased significantly more quickly than the nonloaded group ($P = 0.02$). Compared to the 40 N-loaded group, the 50 N-loaded group of membrane tubes lost much more, but this was not statistically different ($P = 0.92$). Weight loss after 3 months' incubation in phosphate-buffered saline is shown in Table 3. All groups showed rapid weight loss in 1 month, and then decreased slowly. The weight loss of the 50 N-loaded group was 3.27%, while the nonloaded group was lowest, with an average of 2.90%. In all observation periods, the weight loss of the 40 N- and 50 N-loaded groups was significantly different from the nonloaded group ($P = 0.02$). **Abbreviations:** CN, carbon-nitrogen; NH, nitrogen-hydrogen; CH, carbon hydrogen; O=H, hydroxyl; N, loading force.

Meanwhile, as shown in Figure 9, in infrared analysis, the chemical groups of vibration peaks inside the membrane tubes did not change obviously during the degradation. In summary, with 3 months' incubation in PBS, the membrane tube was degraded on the surface, and showed almost no change in internal structure.
