Detailed analysis of allergic cutaneous reactions to spinal cord stimulator devices

Zeshan Ahmed Chaudhry¹
Umer Najib²
Zahid H Bajwa³
W Carl Jacobs⁴
Javed Sheikh⁵
Thomas T Simopoulos⁶

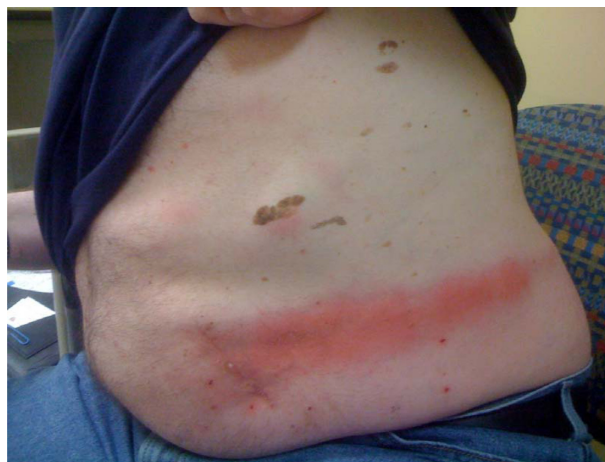
He was seen one week after the operation and his wounds, which included the abdomen for the generator, flank for the extension, and back for lead insertion and anchoring, were noted to be dry with intact incisions, and no erythema, drainage, or tenderness. He was afebrile. At one month post operation, the patient developed a left-sided rash on his flank and abdomen, with no fevers or chills (Figure 1). The stimulator was working well, providing up to 60% pain relief. The incisions over his abdomen, flank, and back were well healed. However, he had an area of erythema/dermatitis that seemed to be localized to the area over the length of the lead extensions connecting the implantable pulse generator to the leads. The reaction did not involve the implantable pulse generator site. It was noted that this rash appeared to

Figure 1 Erythematous rash on the abdomen and flank (case I) primarily overlying the lead extensions.

be an area of reactive inflammation, as opposed to infection, and he was diagnosed with a hypersensitivity reaction to the implanted wires. He was given topical 1% hydrocortisone cream and seen 7 days later, with resolution of the rash.

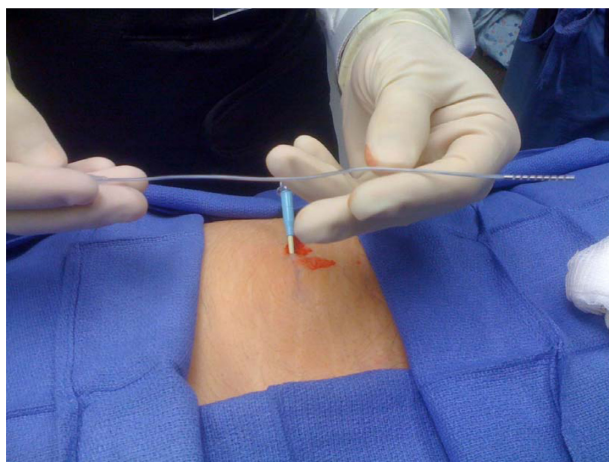
Wound cultures were positive for rare coagulase negative Staphylococci as well as rare *Staphylococcus aureus*, and the patient was treated for 2 weeks with intravenous vancomycin. Clinically, however, he did not manifest with the usual clinical findings suggestive of device infection. One month later, all incisions were well healed. Because the initial reaction to the SCS equipment involved the flank to the abdomen but not the back, the buttock was targeted as a potential site for the implantable pulse generator. In an attempt to rule out a hypersensitivity reaction, an in vivo allergy test using a portion of the extension lead was done (Figure 3). A 4 cm lead extension piece was placed in the left buttock via a 12 gauge

Figure 3 The distal 4 cm of the lead extension pictured above was inserted via a 12 gauge angiocatheter into the subcutaneous tissue of the left buttock in case 1 for in vivo testing.

angiocatheter upon removal of the introducer. The extension fragment was placed into the catheter which was removed leaving the lead in the subcutaneous tissue. The puncture site was closed with 4.0 Monocryl™ suture (Ethicon Inc, Somerville, NJ, USA). After a 2-month follow-up period, there was no cutaneous reaction to the lead extension.

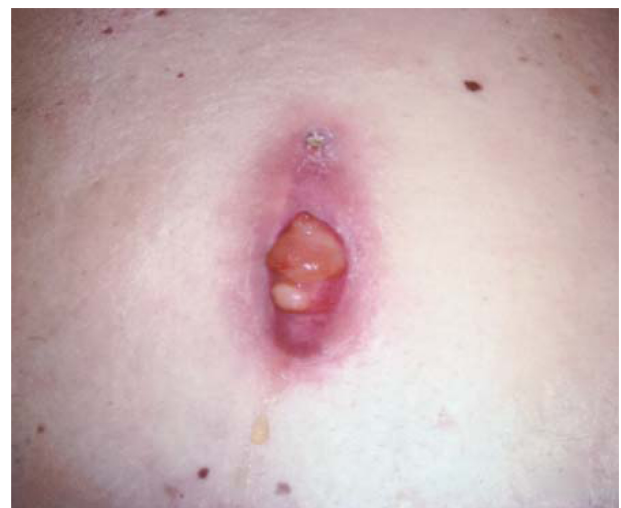
However, despite resolution of the infection, the patient still had a skin inflammatory change that persisted for 5 weeks following implantation (Figure 4). Because of poor

Figure 4 Persistent inflammatory reaction on the upper back (L2 level) 5 weeks post implantation in case 2. Lead strain relief is directly under the inflammatory tissue.

wound healing, the decision was made to remove the dual leads, silastic anchors with associated 0 silk sutures, and the implantable pulse generator. Intraoperative frozen sections revealed acute and chronic inflammation, with a foreign body giant cell reaction (Figure 5A and B). The removal of the soft inflammatory tissue in Figure 4 revealed the underlying leads, and the pocket floor of the implantable pulse generator that had excess lead coils was notable for soft tissue inflammation. Similarly, the tissue was very friable and bled easily with manipulation. Interestingly, there was no fibrotic tissue deposition surrounding the leads, anchors, or the floor of the implantable pulse generator pocket. Normal wound healing then proceeded with an uneventful recovery.
